Corrosion Solutions for Fire Sprinkler Systems

Dry Pipe and Preaction System Solutions

Wet Pipe System Solutions

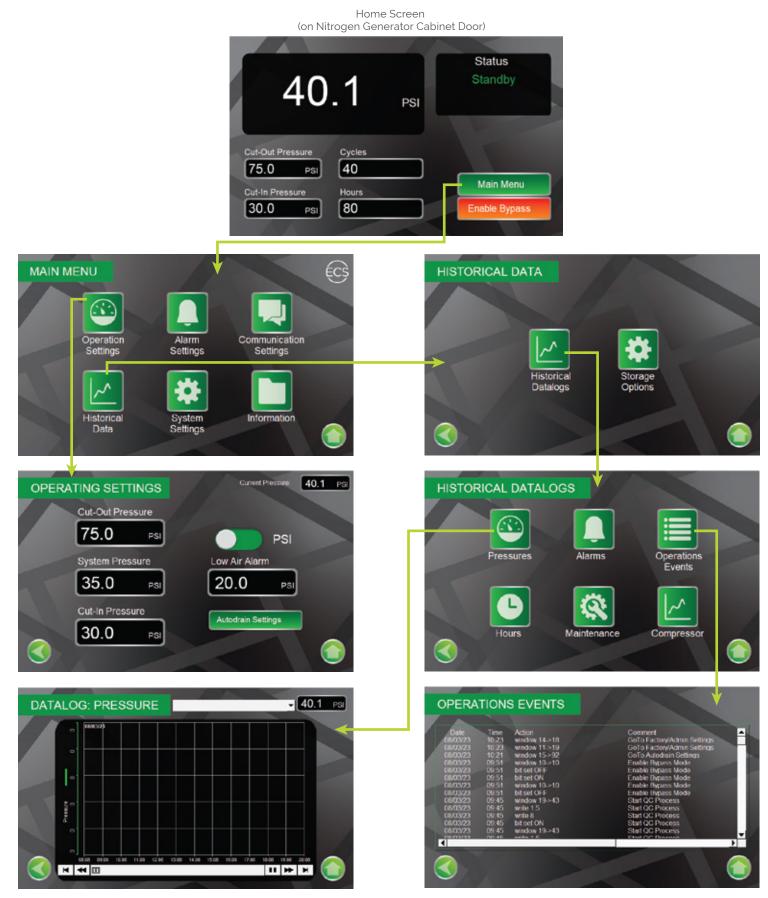
AdvancedIQ Nitrogen Generator User Interface

The Advanced**IQ** HMI display screen allows for easy operation and complete control of the nitrogen generator.

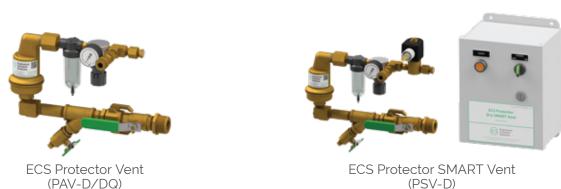
(PAV-D/DQ)

Dry Pipe Vents

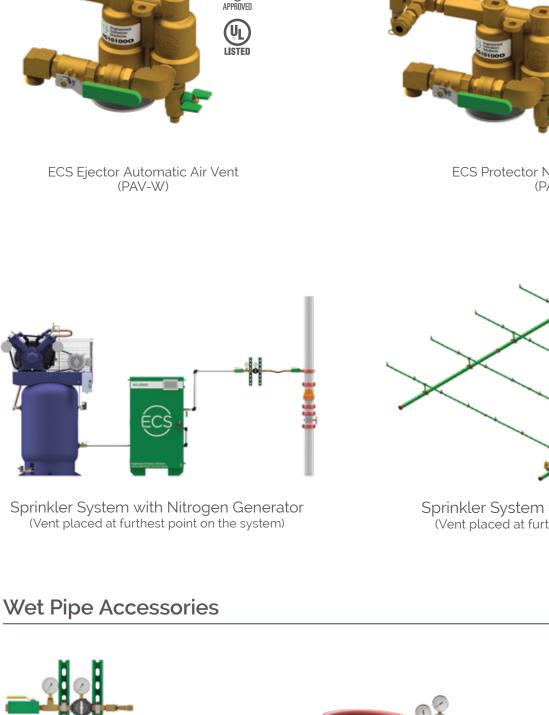
The 2016 Edition of NFPA 13 requires a means of venting air on all wet pipe fire sprinkler systems.

ECS Protector Nitrogen Inerting Vent (PAV-WN)
